Sinclair QL Service Manual

Prepared by THORN (EMI) DATATECH LTD for SINCLAIR RESEARCH LTD

OCTOBER 1985

SERVICE MANUAL X-1204

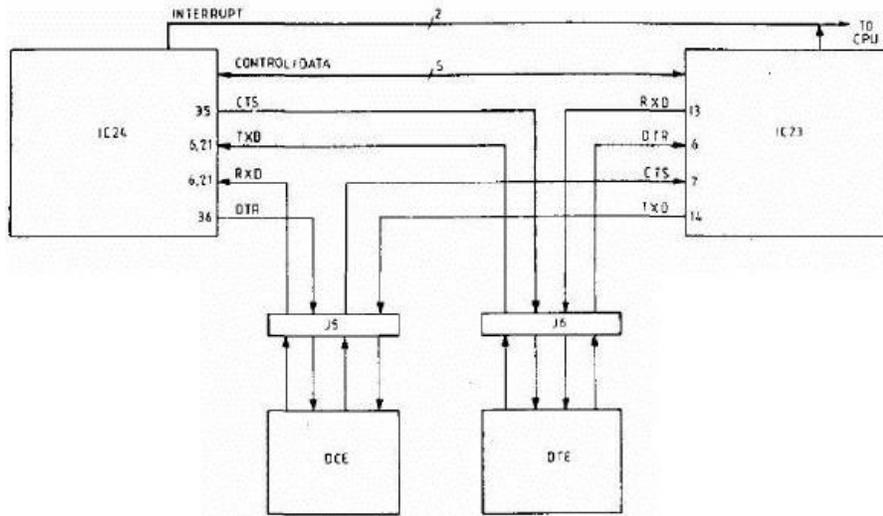
FIGURE 1.1 RS232 LINK

4.8 The RS232 interface uses an 11-bit ASCII data frame, viz. one start bit, eight data bits and two stop bits comprise one character. Two stop bits are always sent but the interface receives compatibly with one except at 9600 baud, where one and a half stop bits are required. Data is transmitted asynchronously in the full duplex mode.

4.9 Consider the QL as the DTE. Both DTE and DCE are switched on and have their DTR signals asserted. CTS and DTR (Clear to Send, Data Terminal Ready) do not form a handshake pair but are similar signals going in opposite directions. Serial data is transmitted by IC23 via driver IC25/6 and received by line receiver IC26/11. From IC26/11 data is fed to NAND gate IC27/9, pin 10 of which is set to the high state by the program, and input to IC24 pins 6 and 21 via IC27/11.

4.10 On receipt of a start bit, IC24 is interrupted, and a subroutine clocks in the data bits, synchronised by the baud rate generator. The data, up to about 20 bytes per RS232 channel, is then buffered in IC24. At the same time, IC24 receives commands (and sends reports) via the serial link with IC18 which is controlled by IC23. When IC24 receives a command from IC18 to empty one of its buffers, it does so, down the serial link via IC23.

4.11 With the QL acting as the DCE data and control is managed in a similar way utilising different IC25 and IC26 receivers/drivers.

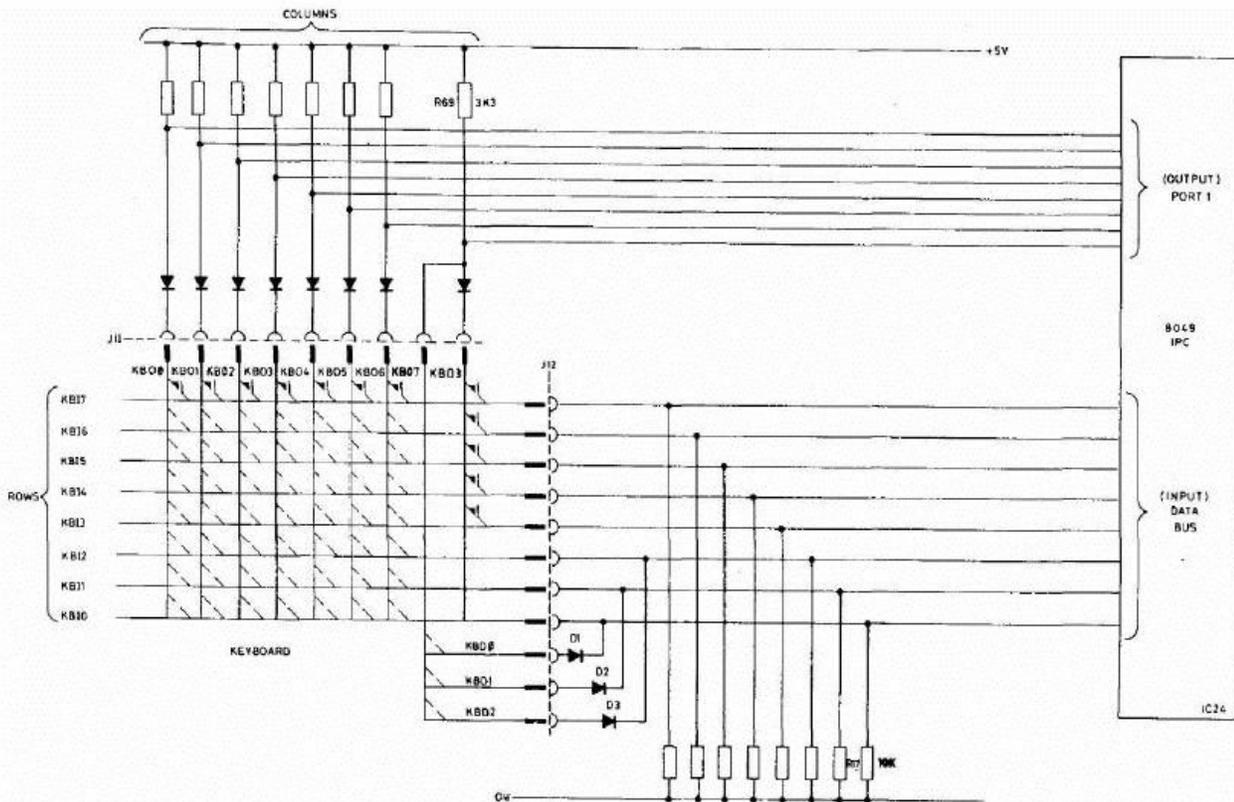
FIGURE 1.2 KEYBOARD MATRIX INTERCONNECTIONS

4.12 Keyboard Monitor. Under program control the 8049 systematically scans the keyboard, recording which keys have been pressed. Figure 1.2 shows the way the keyboard is connected. It consists of an 8 x 8 matrix with one key, the shift key, connected to three input lines. The intersection of each row and column is bridged by a normally open contact. Pressing the key closes this switch. The row 'outputs' and column 'inputs' are shown connected to separate connectors J11 and J12, one to the port 1 outputs of IC24 and the other to the data bus inputs. Pull-down resistors R17 to R24 ensure that when none of the key-switches are closed row inputs KBO0 to KBO7 remain low.

4.13 When the keyboard scanning routines are entered (KBO_n is output, KBIn is input) the 8049 performs successive I/O read cycles setting each KBO0 to KBO7 line low in turn. At the same time the I/O port 1 inputs are scanned.

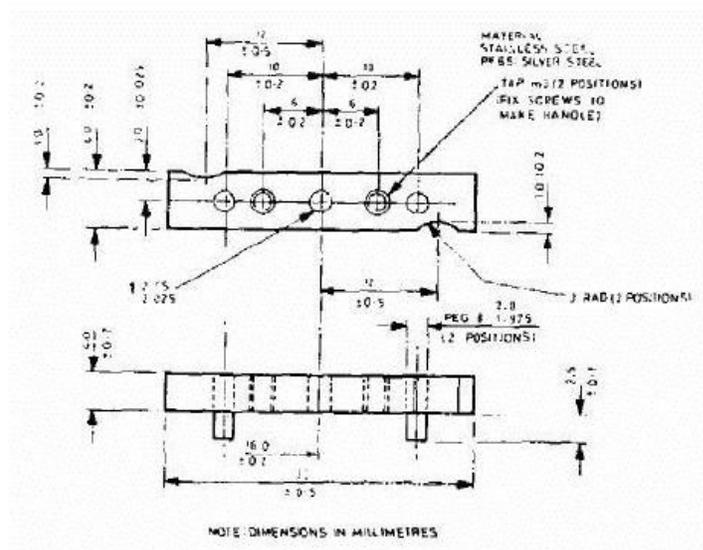
FIGURE 4.1 MOTOR LOCATION JIG

EQUIPMENT	SPECIFICATION/MANUFACTURER
Oscilloscope with probe (x10)	Rise time: 0.02 μ s/cm
Multimeter	General purpose
Colour Television	Open market
New microdrive cartridges	as required, Sinclair
Head cleaner	Open market
Double-sided adhesive tape	Open market
Extension ribbon/connectors for J11, J12 and front panel LED wiring (to enable operation with cover off)	Make up on site
ZX Microdrive	Sinclair
Motor location jig	See Figure 4.1

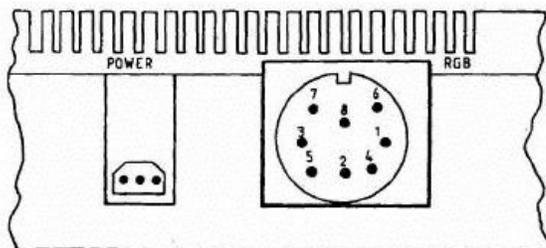
Diagram of Monitor Connection Viewed from the Rear of the QL

1.4 An RGB (colour) monitor can be connected using a lead with an 8-way DIN plug at the QL end. The connection at the monitor end varies according to the monitor (there is no industry standard) and is often supplied with it. A suitable cable with an 8-way DIN plug at one end and bare wires at the other end is available from Sinclair Research Ltd.

1.5 A composite PAL monitor, or the composite video input on some VCRs may work with the QL. Only pins 2 (ground) and 1 (composite PAL) need to be connected via a cable, to the monitor or VCR.

Pin	Function	Signal	Wire Colour	Signal Level
1	PAL	Composite PAL	Orange	1V pk-pk into 75 ohm
2	GND	Ground	Green	
3	VIDEO	Composite Mono Video	Brown	1V pk-pk into 75 ohm
4	CSYNC	Composite Sync	Yellow	0 to 5V TTL (active low)
5	VSNC	Vertical Sync	Blue	0 to 5V TTL (active high)
6	GREEN	Green	Red	0 to 5V TTL (active high)
7	RED	Red	White	0 to 5V TTL (active high)
8	BLUE	Blue	Purple	0 to 5V TTL (active high)

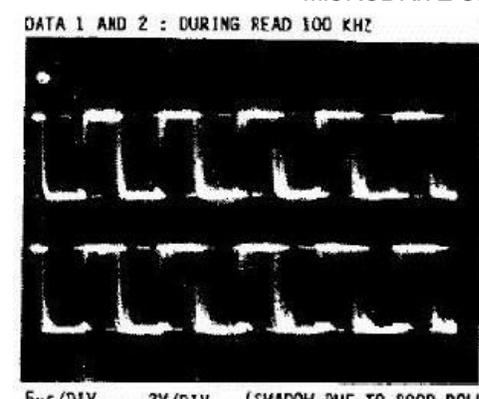
FIGURE D3

5μs/DIV 2V/DIV (SHADOW DUE TO POOR ROLLER)
